Manhole Inspection Summary

Manhole # S150O1029MH

Location Address: **2601 WOODLAND AVE**

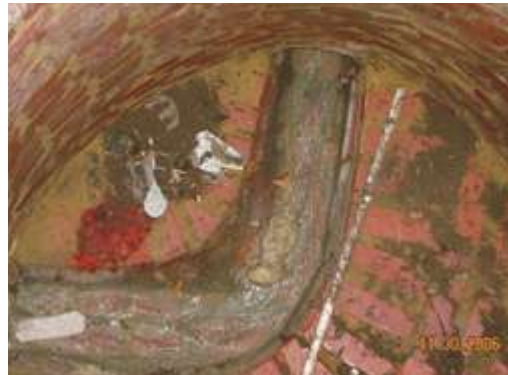
Top View

☐ Parged ☒ **Debris** (not Condition related)

Surcharge ☒ **Evidence Of Surcharge** Depth: **1** (ft.) ☐ Active Surcharge Present

Evidence of surcharge - Bench debris.

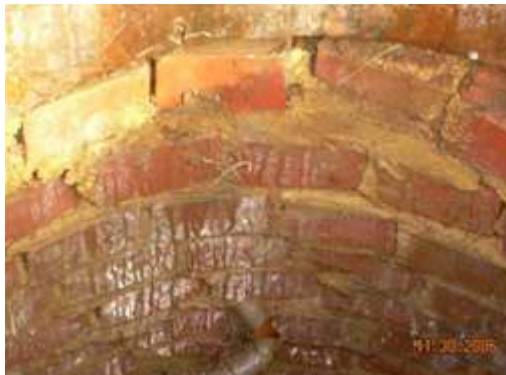
Defect

☒ **Leaks**

Condition: ☐ Sound ☐ Cracked ☐ Root Intrusion ☐ Loose Brick ☒ **Deteriorated**

Infiltration: ☐ None ☒ **Joint** ☐ Cracks ☒ **Mortar** ☐ Roots ☐ Wall

Frame leaks. Adjustment deterioration and infiltration.

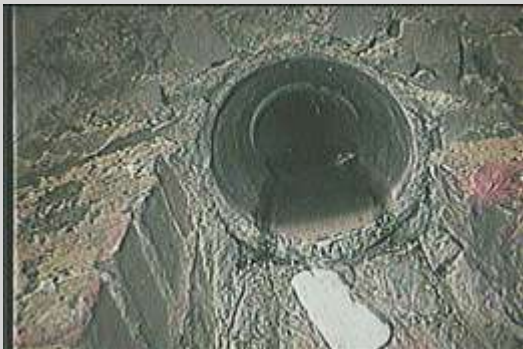
8 in. Circular Gravity Sewer Pipe In @ 9 O'Clock

Channel deterioration.

Infiltration: **None** Pipe Seal Cond: **Cracked**
